EFFECTS OF ALCOHOL FUELS ON ENGINE WEAR

**INTERIM REPORT
AFLRL No. 133**

**U.S. Army Fuels and Lubricants Research Laboratory
Southwest Research Institute
San Antonio, Texas**

October 1980

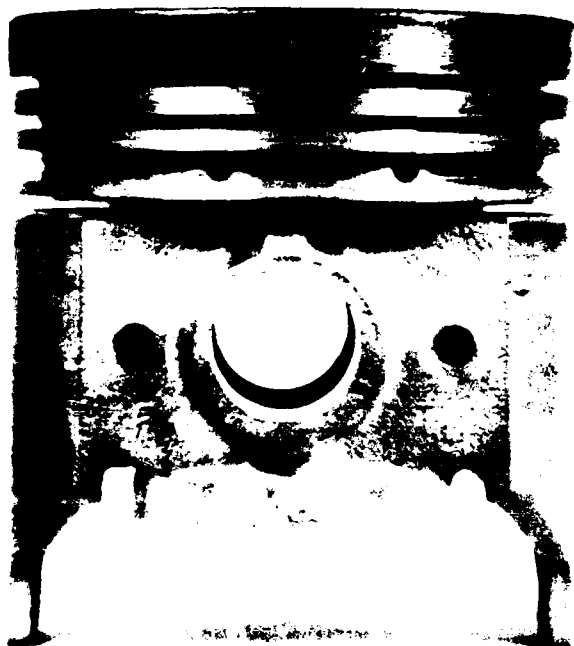
FIGURE 4. MODIFIED ASTM SEQUENCE II-C CYCLE CLR PISTON DEPOSITS - 50 HOURS
Front View

Test 1
Unleaded Gasoline

Test 2
100% Methanol

Upon disassembly, it was found that the entire engine was coated with a stable yellowish foam that varied from 1.3 to 5.1 cm (0.5 to 2 inches) in depth. Removal of the foam revealed no sludge or varnish deposits except in the piston ring zone area and the intake valve tulip, two relatively hot areas exposed

to the oil (Figures 4, 5, and 6). These two areas were coated with a black tar-like deposit. Infrared analysis indicated that these deposits were not similar to the oil, but may be related to the oil's additive package. The methanol-fueled engine had considerably heavier piston deposits and had a CRC piston rating of 114. While this deposit level is greater than the 39 rating with gasoline, this is not an excessive level. Both compression rings were sluggish, although this had not affected the blowby flow rate. The chrome top compression ring gap increased 0.051 mm (0.002 inches) and the cast iron second ring gap increased 0.10 mm (0.004 inches). Neither the cylinder bore nor the bearing showed any significant wear. Apparently, 50 hours of operation were too short for extensive wear to develop.

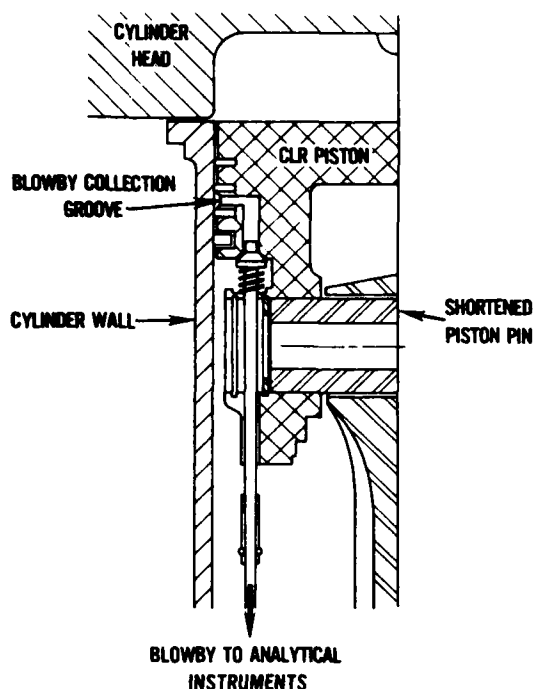
FIGURE 15. BLOWBY DIVERSION PISTON SCHEMATIC

a system for sampling the gases in the ring zone of the CLR engine was installed.⁽⁸⁾ This sampling system, shown in Figure 15, consisted of a blowby expansion and collection chamber in the piston connected to the exterior of the engine via a sliding tube arrangement. The gases passed through this tubing to a collecting system located adjacent to the engine. The tubing located within the engine was brass, while the external tubing and associated plumbing was either Teflon[®] or stainless steel. Such a sampling system cannot assure a quantitative measure of the gases present in the ring zone since the combustion products may continue to react and change in composition during the extraction process. However, this system should nevertheless provide an indication of the original gas composition.
